National Highway
Traffic Safety
Administration

Case Vehicle (A): 2000 Dodge
Type: Ram 1500, 4x4 pickup
Driver: 26-year-old female
CDC: 12-FCEN-1, 12-FLEE-5, 03-RFEN-1

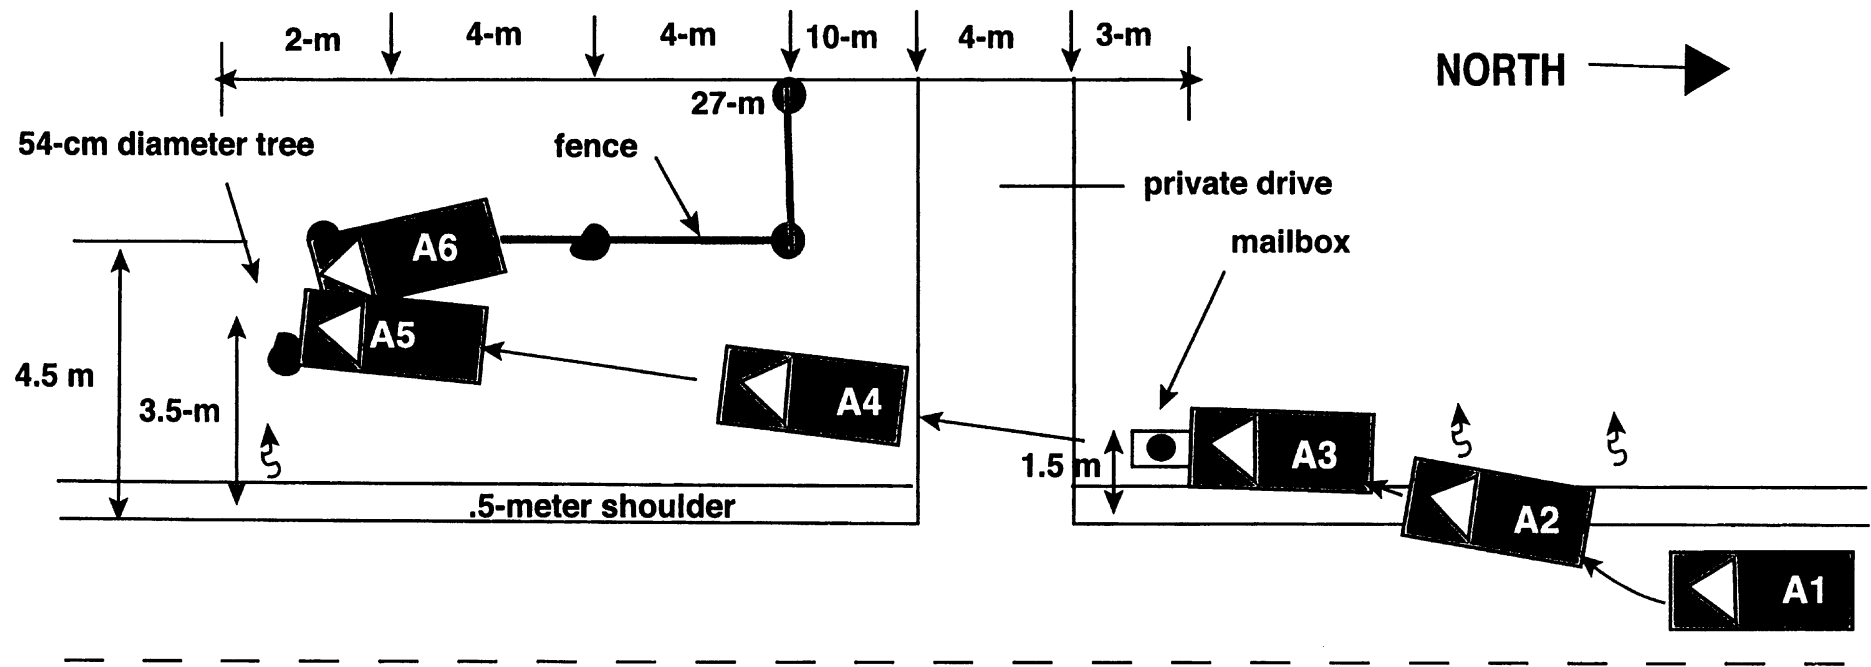
ACCIDENT SCHEMATIC

ACCIDENT DESCRIPTION: CASE VEHICLE (A) WAS SOUTHBOUND
WHEN THE VEHICLE LEFT THE WEST EDGE OF
THE ROAD. IT TRAVELED IN A SMALL DITCH AND
STRUCK A MAILBOX WITH ITS FRONT. IT CONTINUED SOUTHBOUND, CROSSED A
PRIVATE DRIVE AND STRUCK A 54-CM TREE WITH ITS LEFT-FRONT CORNER.
AFTER THE IMPACT WITH THE TREE, THE VEHICLE ROTATED COUNTERCLOCKWISE
AND STRUCK A FENCE POST WITH ITS RIGHT FENDER.

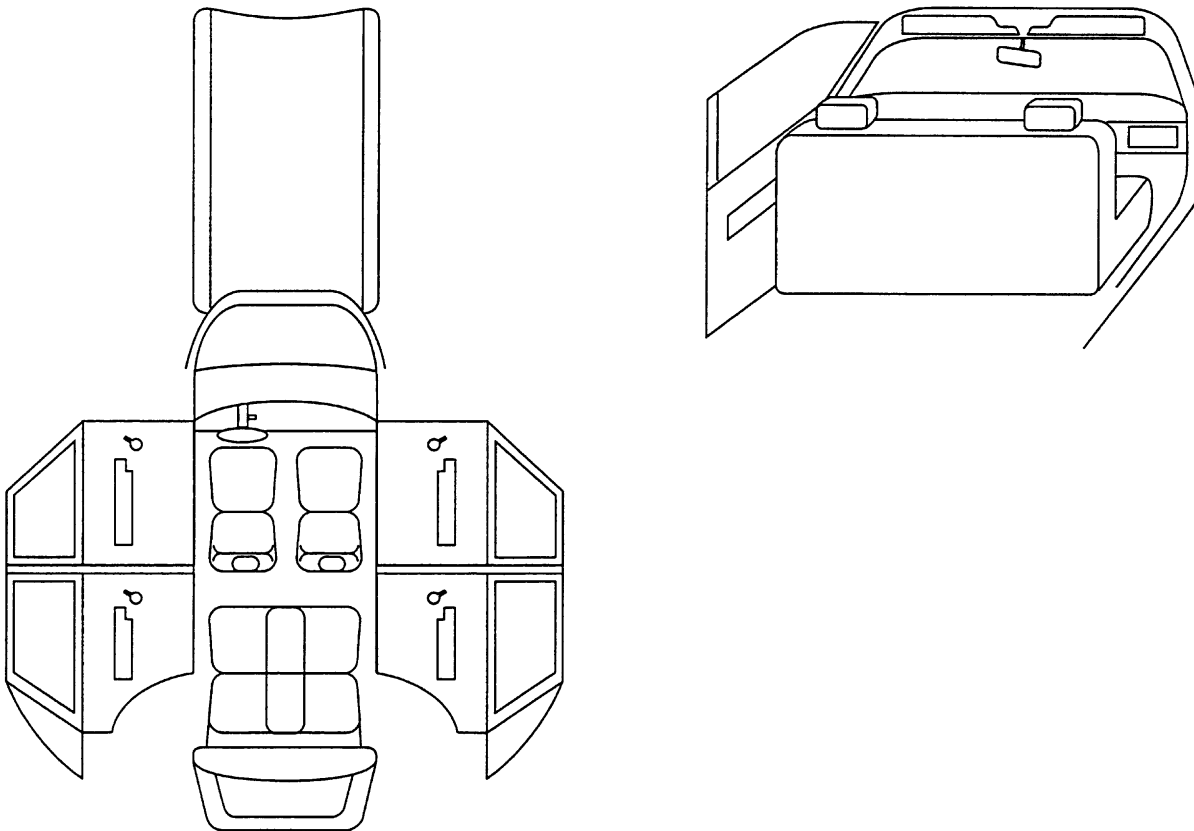
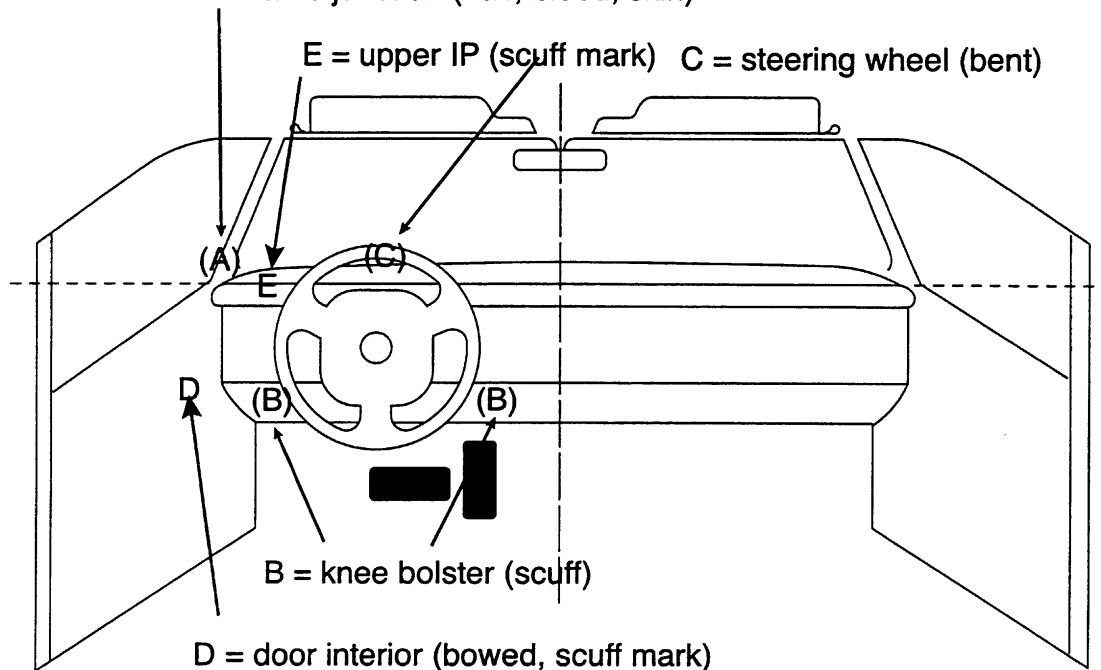
VEHICLE OCCUPANT CONTACT DIAGRAM

A = interior door panel at the window
frame junction (hair, blood, skin)

E = upper IP (scuff mark) C = steering wheel (bent)

B = knee bolster (scuff)

D = door interior (bowed, scuff mark)

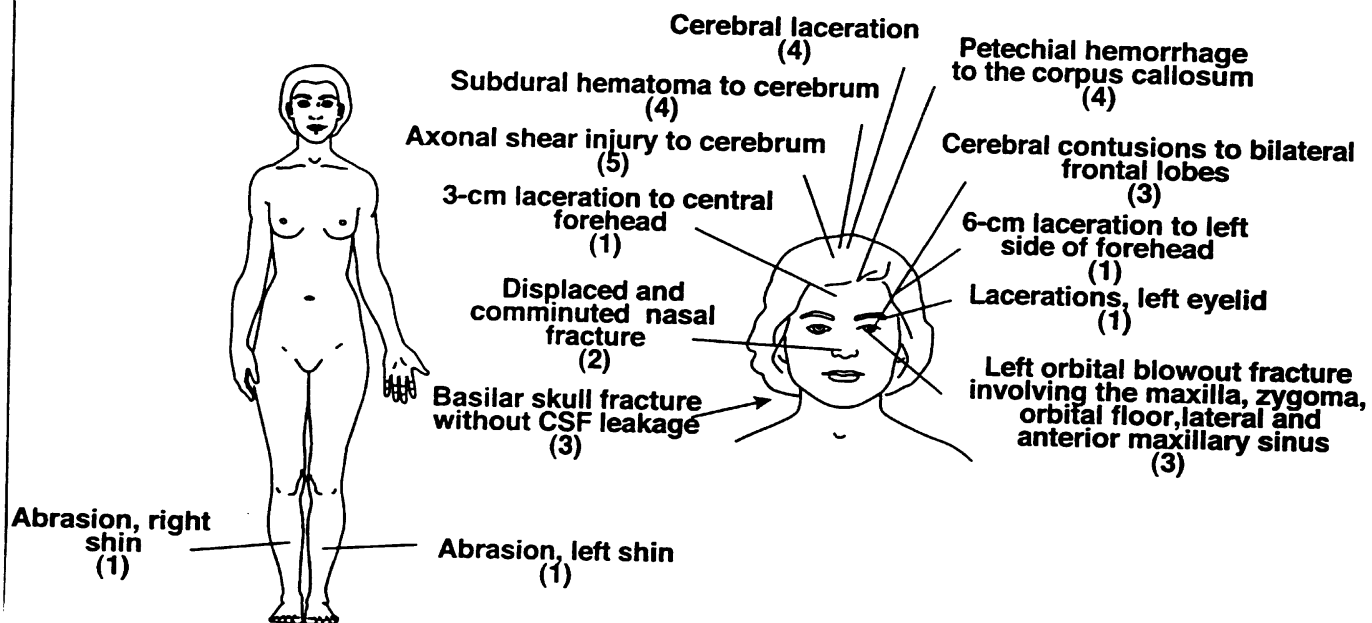
INDICATE LOCATION OF INJURIES.

The driver sustained severe head and facial injuries from the contact with the top of the driver door at the junction of the window frame. These include axonal shear injuries to the cerebrum, cerebral laceration, petechial hemorrhage to the corpus callosum, and a subdural hematoma to the cerebrum. Also, she sustained cerebral contusions to bilateral frontal lobes, and a basilar skull fracture without a CSF leakage. In addition, she sustained a 6-cm laceration to the left side of her forehead, a 3-cm laceration to the center area of her forehead, and lacerations to her left eyelid.

etoh = .18 percent blood + for opiates
